CORPS OF ENGINEERS  
NATIONAL DAM INSPECTION PROGRAM  
BOSTON AREA - MASSACHUSETTS COASTAL BASIN

SLUICE POND DAM

MA 00236

DELETED FROM PROGRAM  
(LOW HAZARD POTENTIAL)

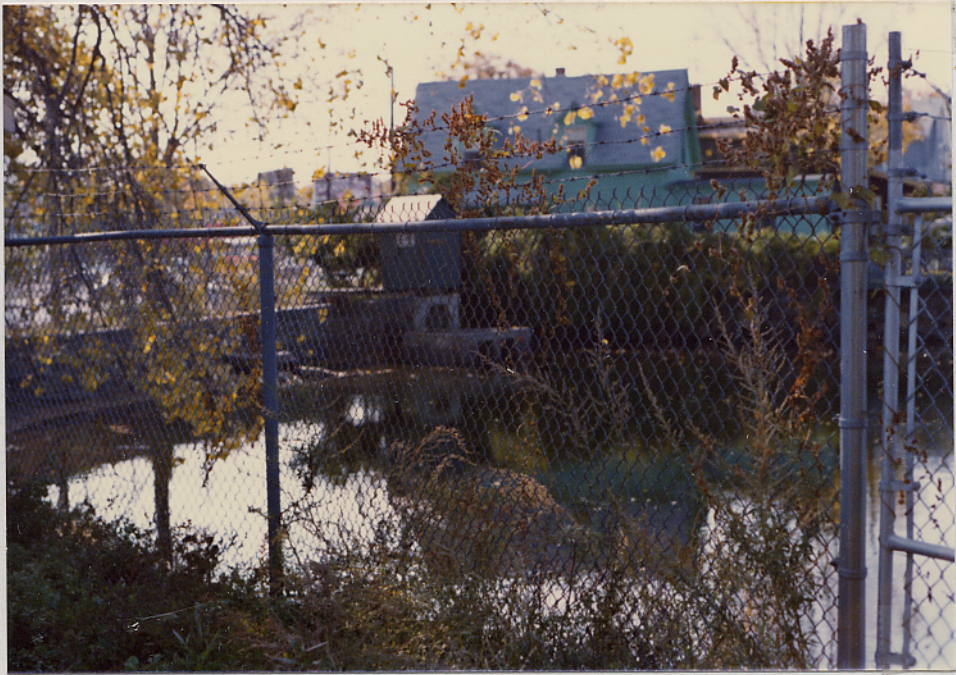
PHOTO NO. 1 - Shows the upstream face of the Sluice Pond Dam embankment. The inlet works can be seen in the center center of the photo. The screened inlet and gate house were constructed about 1949. To the left of the gate house is an inlet structure for a 30 inch outlet pipe. Both outlets are connected to the storm drain in the street (Broadway) which forms the embankment. This underground drain flows along side the church, school, ball field and apartments (See Photos Nos. 2, 3 & 4) and then into Flax Pond, about 1500 ft. downstream.

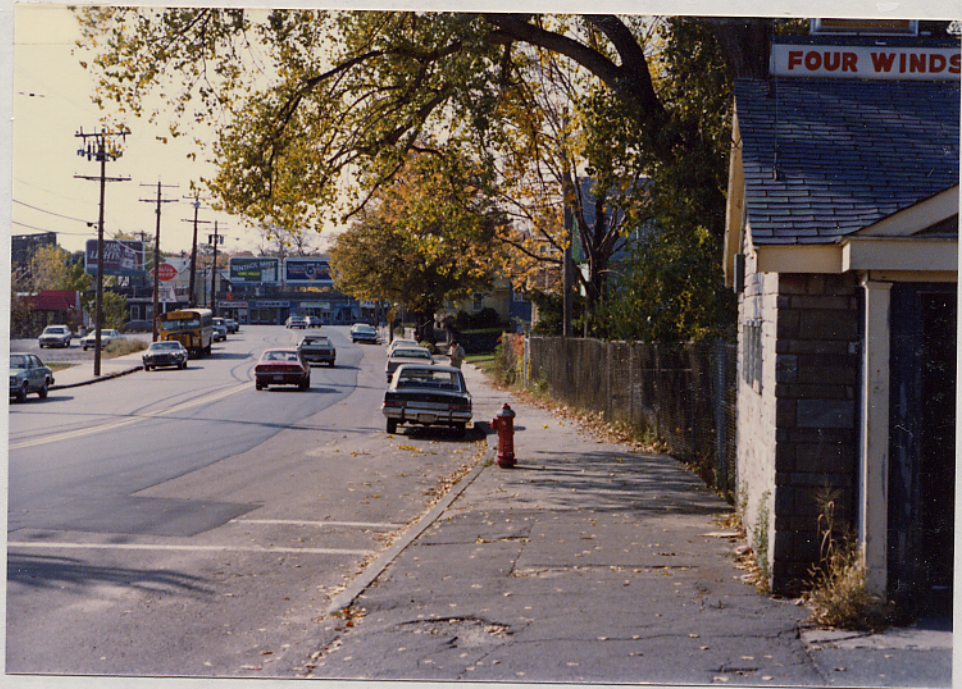
PHOTO NO. 2 - Shows the Dam embankment looking along Broadway. The original Dam was about 10 ft. high at this location. It has been modified by the roadway. The height on the upstream face is about 6 ft. The width and length of the roadway are about 78 and 130 ft., respectively.

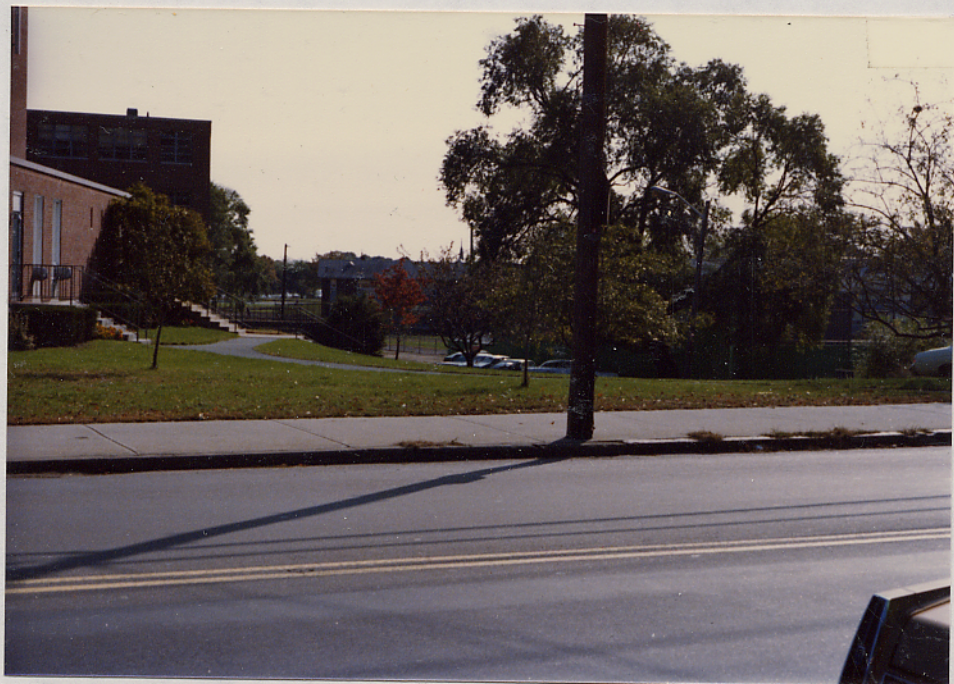
PHOTO NO. 3 - Shows the immediate downstream area, at the Dam. The lowest areas (at the center of the photo) shows a parking area, part of the play field and the apartments. Beyond the apartments, a section of Flax Pond can be seen. The apartments were constructed upon a fill which is very level and extends up onto Flax Pond and about 4 ft. high.

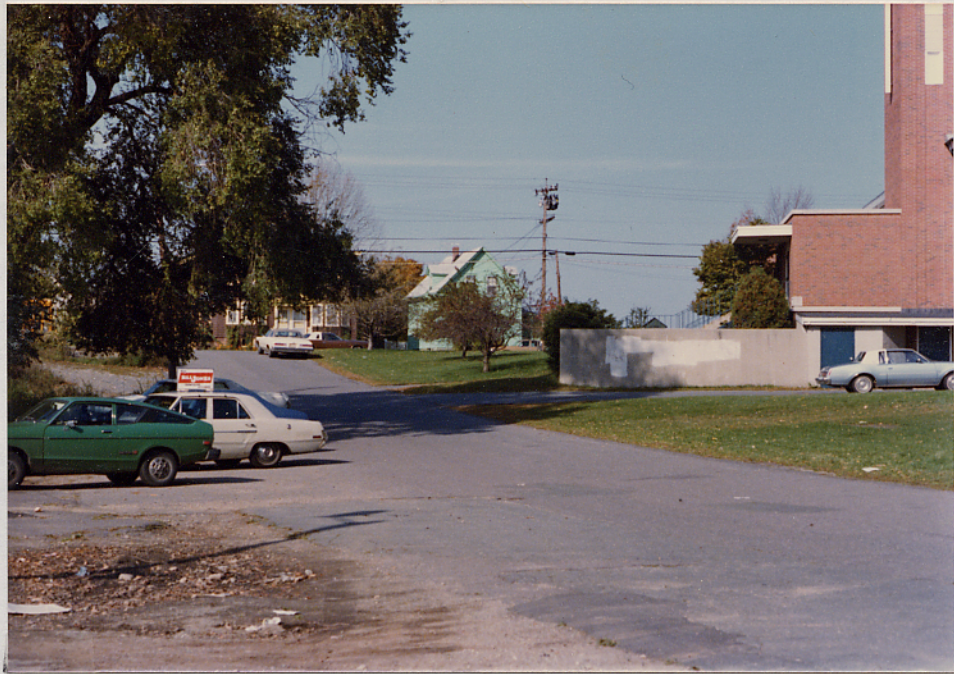
PHOTO NO. 4 - Shows the downstream area of the Dam embankment formed by the roadway fill. This is the parking area noted in Photo No. 3. The embankment height is about 10 ft. The play field area beyond, is very flat and wide. It extends to Flax Pond. All other development around the play field is at higher elevations.

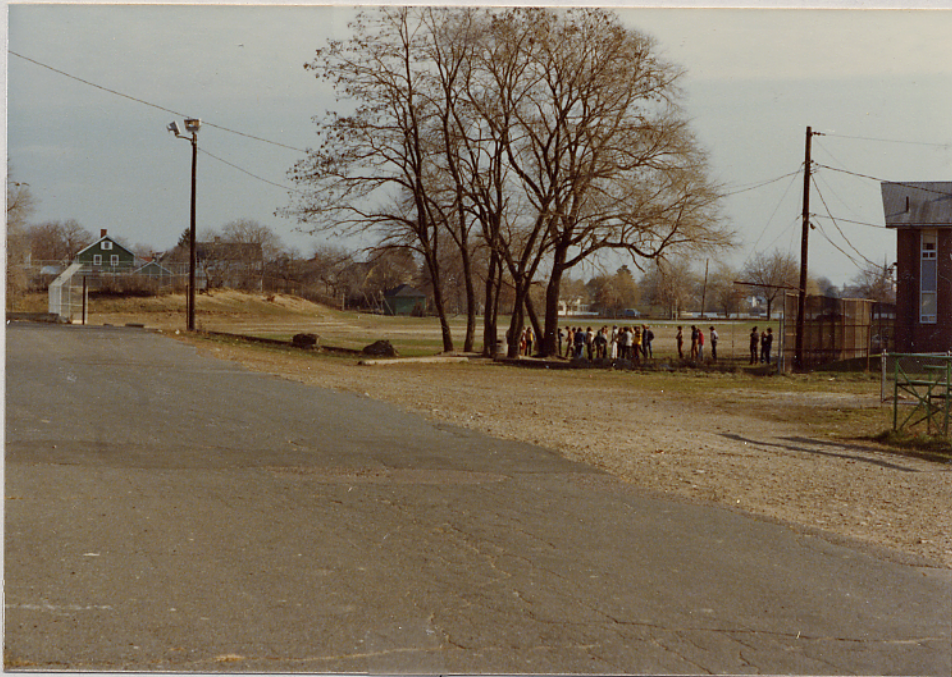
PHOTO NO. 5 - Shows the relationship of the wide, flat field to the developed areas around it. Flax Pond can be seen to the right center of the photo. The first floor level of the apartments is about 4 ft. above the field level.

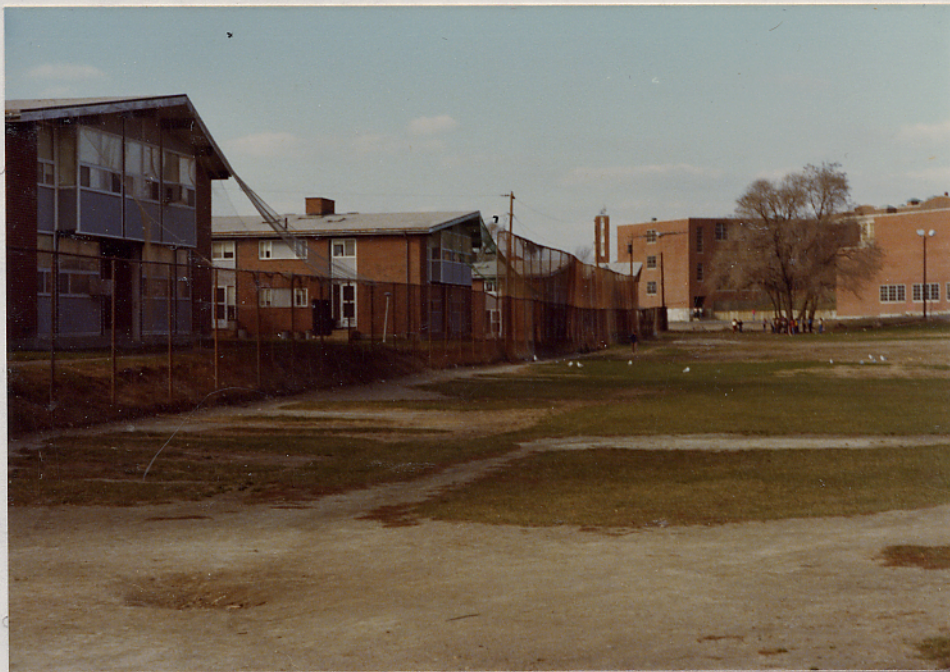
PHOTO NO. 6 - Shows the apartments and field area as seen from the roadway adjacent to Flax Pond. The Sluice Pond Dam outlet pipe and street drain is buried near the fence. This area has been filled.
